# Hydra Bio Troubleshooting: frequent issues and how to solve them

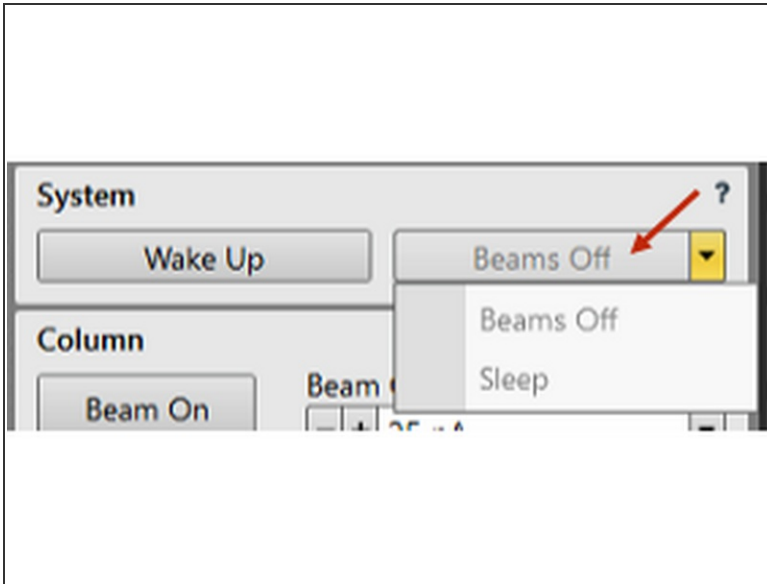
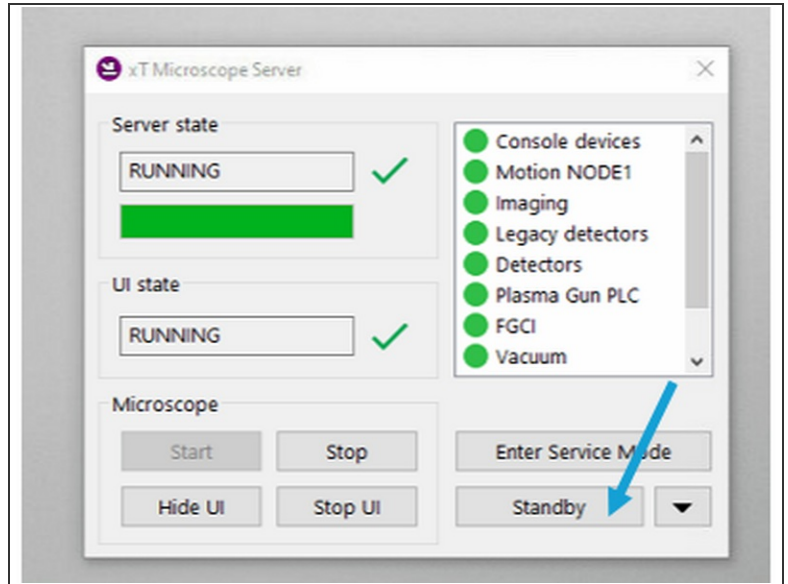
## Step 6 — Unusual microscope hardware behaviour (second line treatment) - Power-cycle microscope

⚠ If the microscope PC restart didn't work, you may power-cycle the microscope hardware. **In any case, please inform the responsible persons before proceeding with this step.**

⚠ Unload your sample, as the stage may warm above -150°C.

- First stop UI and then stop Microscope as in the previous [Issue #5](#).
- Bring the stage to 0° tilt in Stage -> Tilt 0°. (Ctrl+E)
- Switch off beams or put them to sleep.
- Click Standby button and confirm the following pop-up messages. Wait 30 seconds and start up the system again.
- Double-click xT microscope server -> Start microscope -> Start UI (started automatically). Use login credentials from [Issue #5](#). In the xTUI follow these steps: i) Home stage when prompted, ii) apply 180° scan rotation for SEM and FIB views, iii) home the stage (Shift + F3) and iv) wake up the system.

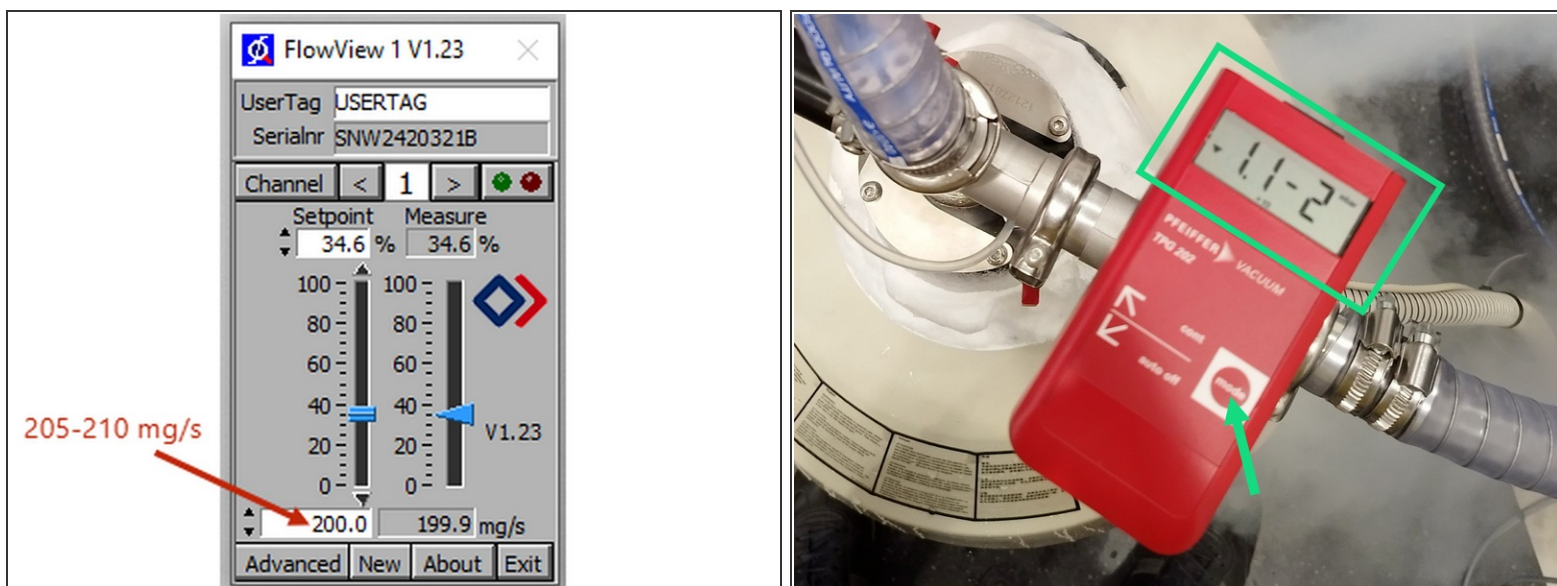
## Step 7 — Elevated stage temperature (> -180°C)

- ❗ Due to the stage cooling solution, the level of nitrogen in the heat exchanger dewar affects the cooling efficiency of the stage. As the N2 level lowers, the cooled nitrogen gas warms up slightly in the upper part of the dewar, thus the stage temperature elevates. Once the dewar is full, the temperature sinks again.

- Check if the pressure is below  $2 \cdot 10^{-2}$  mbar in the vacuum protection tube by **pressing Mode button once**. If the pressure is higher, it may be a sign of ruptured tubing.

- ☑ The default nitrogen flow rate is 200 mg/s.
- First, check if the nitrogen dewar is filled. If needed, initiate dewar filling based on [Step #7 of the automated nitrogen filler protocol](#).

- **Increase gas flow** in the FlowView window 205-210 mg/s.
- ⚠ If the temperature doesn't decrease in the next minute, it may be a sign of an ice clog. Try to remove it by increasing flow to 250mg/s. If temperature still doesn't decrease, evacuate your sample and cryo-cycle the instrument (ca. 2 hours).
