## John Deere - HRN-GR09K1

Harness modification requirement for some John Deere vehicles using GoRugged with HRN-GR09K1.

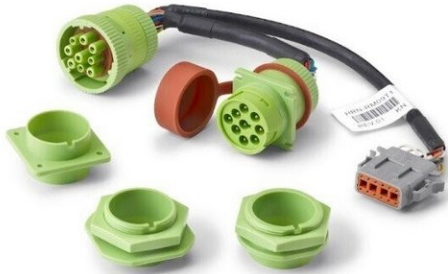
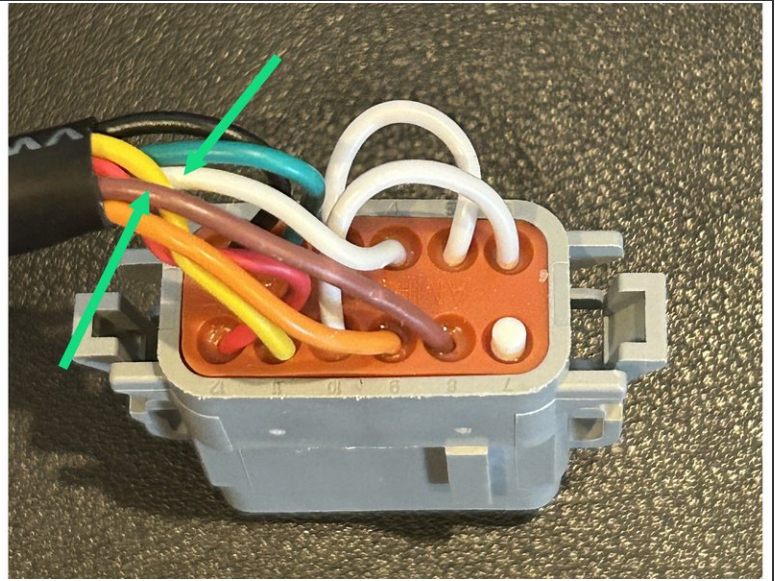
**— John Deere - HRN-GR09K1**

In some cases you will see error codes on the dash and lose joystick functionality.

The modification to remedy this is to cut the pins F and G on the harness.

- ❗ Cut the **Brown wire** and **White wire** as shown in the image.
- ☑ Snip the wire close to the harness to avoid a floating wire, and insulate with tape.
