2019 Sprinter (907) Radio Replacement - S.O.S. Light Fix

How to fix the problem of S.O.S. light illuminating after replacing the stock radio in a 2019 Sprinter with an aftermarket unit.

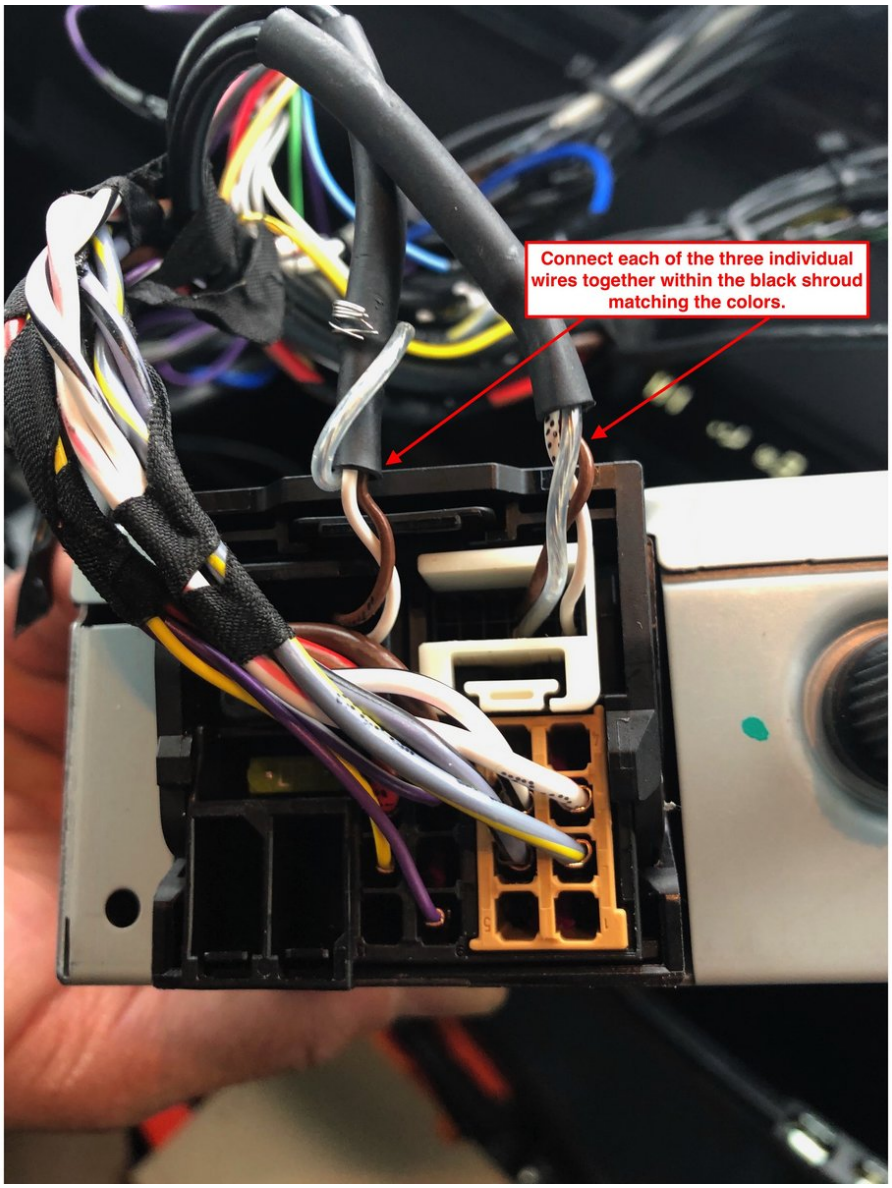
Step 1 — 2019 Sprinter (907) Radio Replacement - S.O.S. Light Fix

- There are 2 cables with a black casing that enter the radio harness. Each casing houses (3) wires. Those wires need to be connected together, individually, matching the colors, in order for the S.O.S. microphone to be able to continue communicating with the system without the original radio present.
